WATER QUALITY STUDY
OF THE
EAST FORK LITTLE SANDY RIVER

February 1992

KENTUCKY DEPARTMENT FOR ENVIRONMENTAL PROTECTION
DIVISION OF WATER
WATER QUALITY BRANCH

WATER QUALITY STUDY
OF THE
EAST FORK LITTLE SANDY RIVER
(MILE 25.4 TO MILE 17.0)

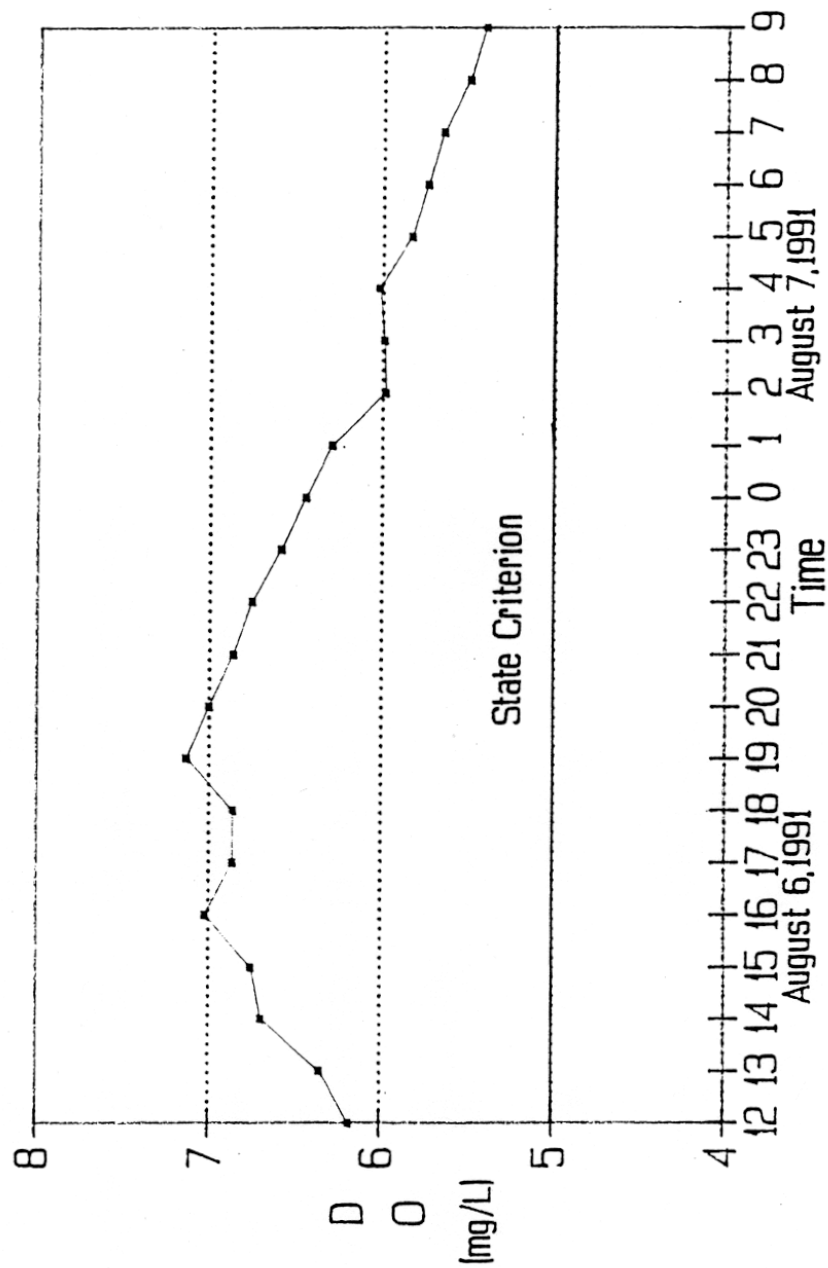
Figure 2: East Fork at Mile 22.8
DO vs Time

to the East Fork at mile 24.3 (Site 4) were dry. Although the sampling sites on these streams were below wastewater facilities, these primarily serve schools which were not in session. DO in the East Fork at mile 22.8 (Site 5) was above the state criteria over a 21 hour period beginning at noon on August 6 and ending at 9:00 A.M. on August 7 (Figure 2). Oil was again observed on the water surface. A local resident indicated that the oil was recent, but he did not know its source.

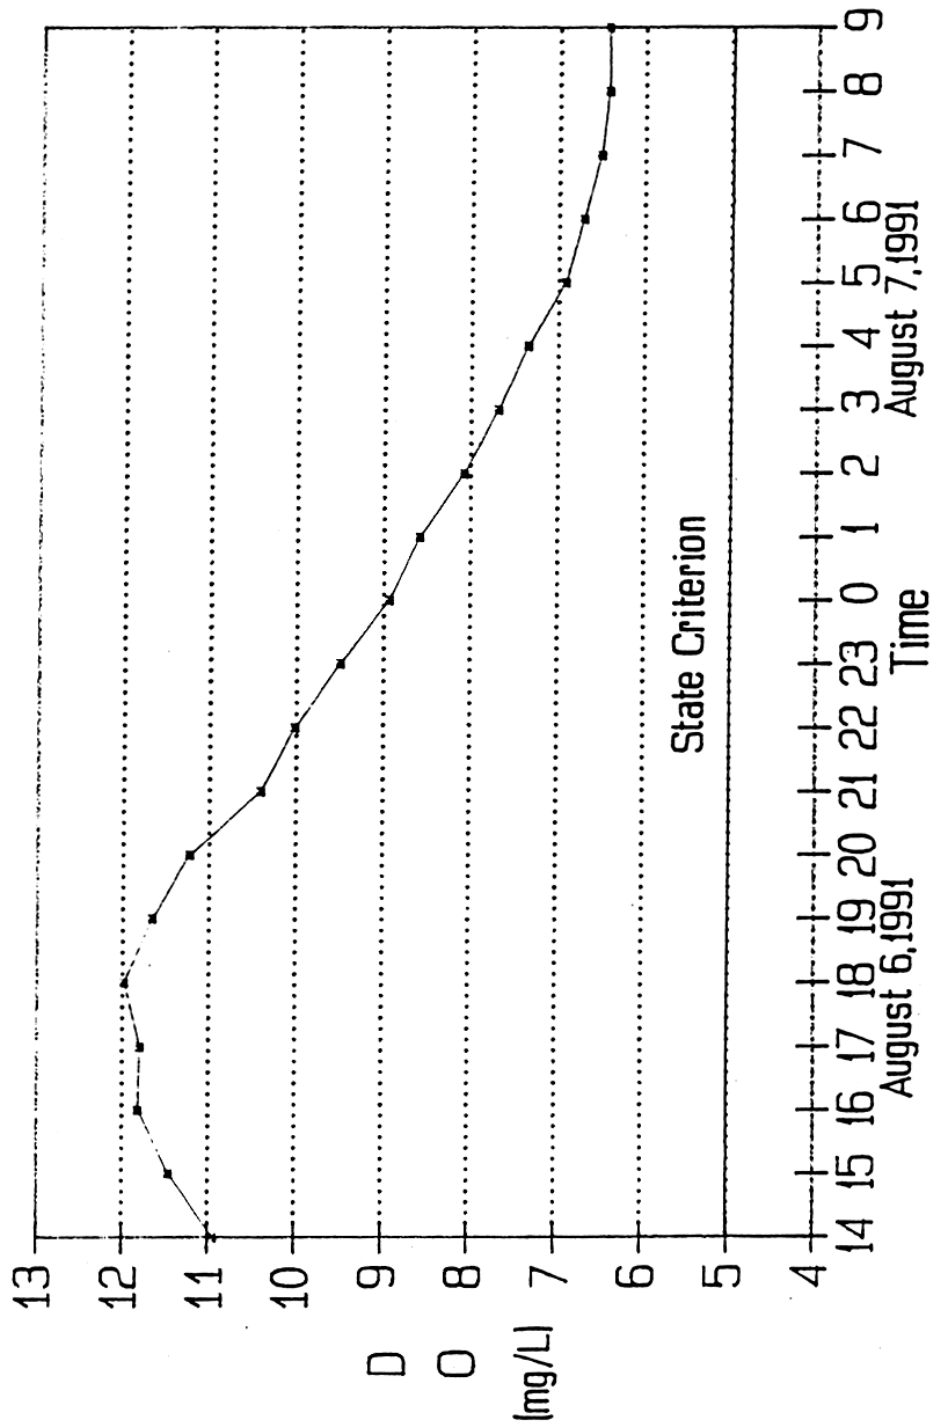
Figure 3: East Fork at Mile 21.7
DO vs Time

DO concentration in the East Fork at mile 21.7 (Site 7) also was not below state criteria over a 19 hour period beginning at 2:00 P.M. on August 6 (Figure 3). The curve on Figure 3 is typical for streams, with a smooth upward rise to a peak in late afternoon and a slow decline before dawn. This area is a long pool exposed to full sun during daylight hours. Oil, however, was again visible on the water surface.

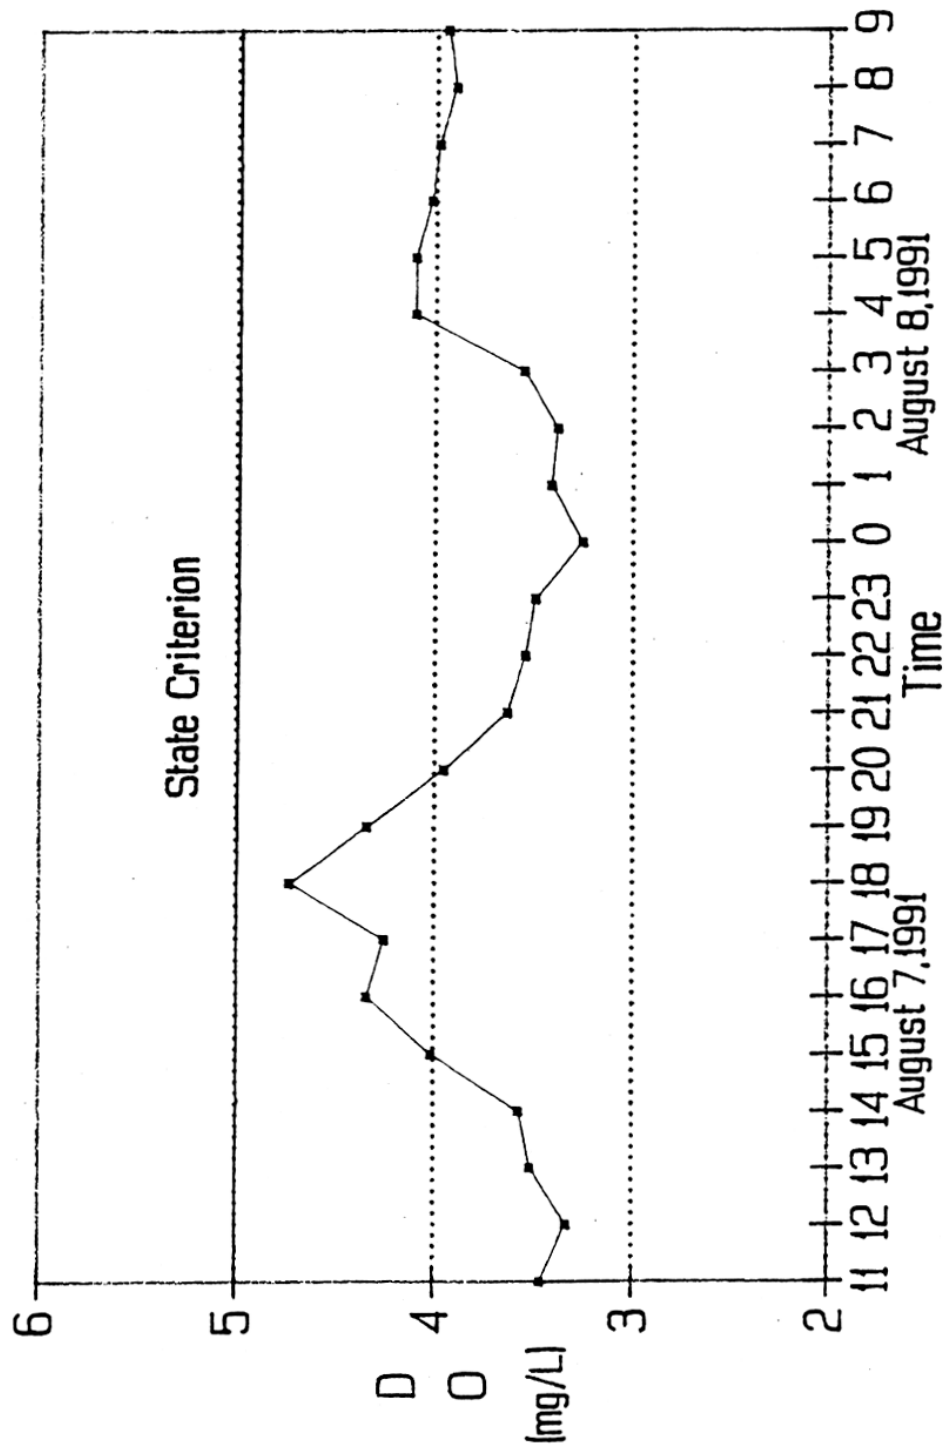
Figure 4: East Fork at Mile 20.0
DO vs Time

The East Fork at mile 20.0 (Site 11) and mile 17.0 (Site 12) exhibited severe problems. Dissolved oxygen did not exceed 5.0 mg/L at either location over a day-night cycle (Figures 4 and 5). DO at mile 20.0 was often less than 4.0 mg/L, while the mile 17.0 site generally remained at about 4.5 mg/L. In addition, the cycles did not exhibit the normal type of curves, but were erratic over the period. Both sites are below the majority of the wastewater facilities, and water quality is likely affected by their effluents. This reach also has a heavy tree canopy which would reduce photosynthesis by blocking sunlight during daylight hours, and both sites had oil on the surface.

Based on Kentucky Water Quality Regulations, Title 401 Chapters 5:005 Section 7(3) and 5:055 Section 2(3) and the results from this study, it is recommended that the Division continue to deny new or expansion of package wastewater facilities in this area of the East Fork and its tributaries. Completion of the sewer extension project to eliminate existing package facilities is essential for future growth and development. Once completed, the Division should conduct a follow-up study to document water quality
